**Flood Control Project Maintenance  
Levee Inspections**  
**LMA District Cover Sheet**  
**Spring 2018 Levee Inspection Results**

**Sacramento Maintenance Yard Putah Creek**

**Spring 2018 Levee Inspection Results**

Waterway			Bank	Unit Miles
Unit No. 01 Putah Creek or North Levee			Left	8.79
	Spring (March - May)	Summer (June - August)	(September - November) Fall	Winter (December - February)
Unit Maintenance Rating (Fall Only)				
Date of Inspection	3/8/2018 - 3/8/2018			
DWR Inspector	Keith Millard			
Accompanied By

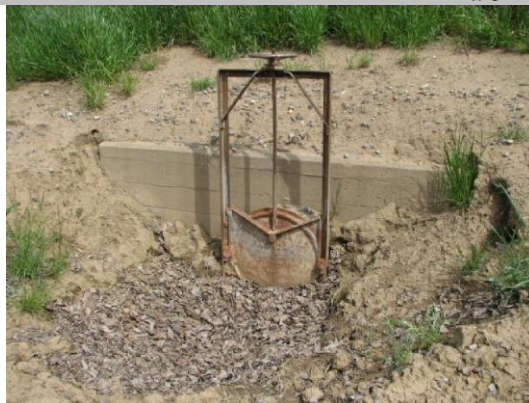
Photo 1 of 2 : UCIP\_SP\_2018\_33394\_60458.jpg

WS Slide gate

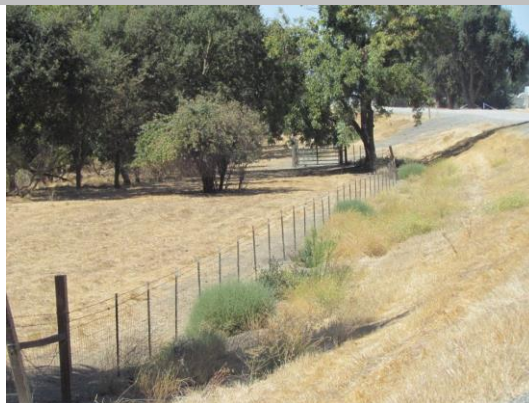
Photo 1 of 1 : SP\_2018\_ST0007\_282\_4\_20180305\_00002.jpg

LM Start	3.25	Rating **	M	Issue No.	4
LM End	3.64	Issue Type +	En	Location *	WS
Category	Earthen Levee			GPS Latitude/Longitude	
				Start	End
Item	Encroachments			38.519831 °	38.519848 °
				-121.686263 °	-121.693463 °
DWR ID	DWR_ST0007_01_s_2013_4				
Comment Code					
FE : Fence					
Inspector Comment					
No permit for this wire fence waterside levee slope.

Wire fence within the 10-foot easement waterside levee toe.

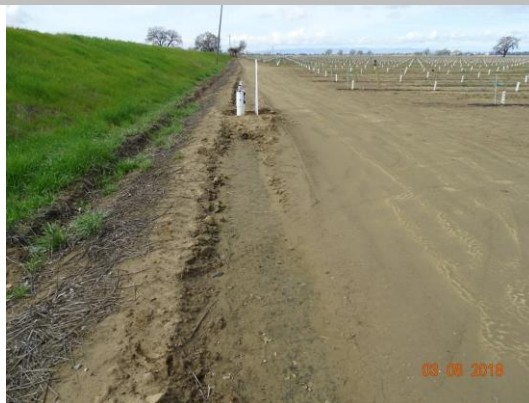
Photo 2 of 2 : SP\_2018\_ST0007\_282\_39\_20180312\_00112.jpg

LM Start	4.32	Rating **	M	Issue No.	39 (cont)	
LM End	4.80	Issue Type +	En	Location *	LS	
Category	Earthen Levee			GPS Latitude/Longitude		
				Start		End
Item	Encroachments			38.518280 °		38.518041 °
				-121.704657 °		-121.713680 °
DWR ID	DWR_ST0007_01_s_2018_39					
Comment Code						
PI : Pipe						
Inspector Comment						
Newly planted orchard on LS appears to have installed a water pipe with visible risers parallel to levee approx 8 feet from toe. This pipe should be verified, and owner should contact CVFPB for direction.

Suspected trenchline for new pipeline running parallel to levee, 8 feet from toe.

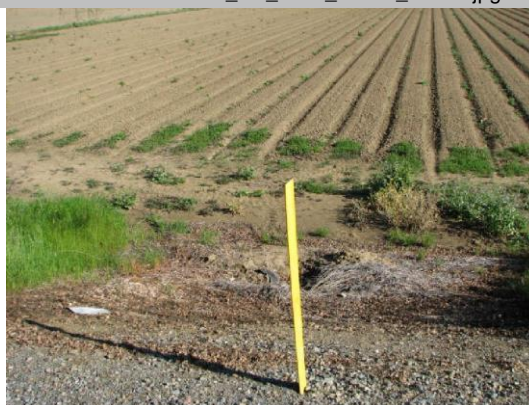
Photo 2 of 3 : UCIP\_SP\_2018\_33374\_60423.jpg

LS shoulder looking down on headwall

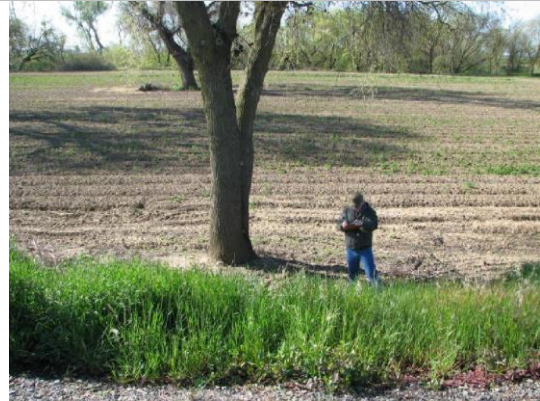
Photo 3 of 3 : UCIP\_SP\_2018\_33374\_60425.jpg

WS toe looking down from shoulder

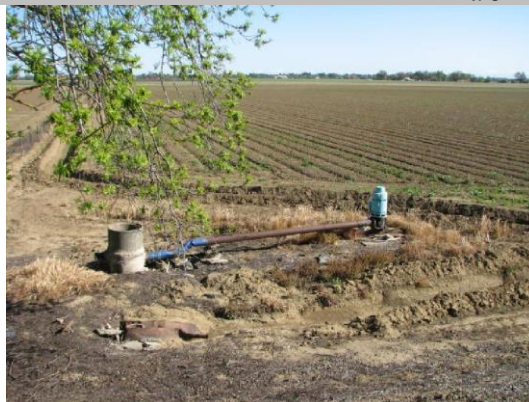
Photo 1 of 2 : UCIP\_SP\_2018\_33370\_60415.jpg

LS pump and stand pipe

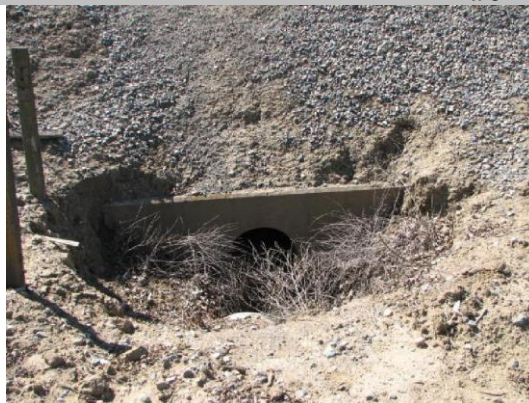
Photo 1 of 2 : UCIP\_SP\_2018\_33368\_60410.jpg

LS headwall

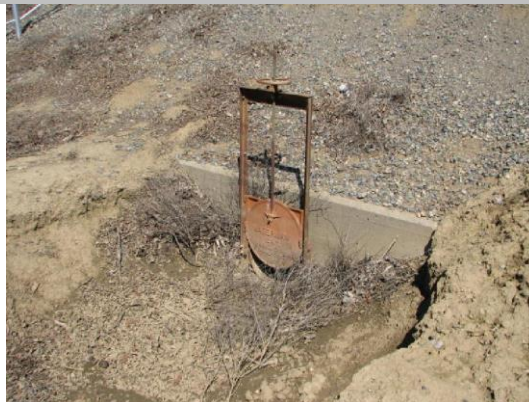
Photo 2 of 2 : UCIP\_SP\_2018\_33368\_60409.jpg

WS slide gate

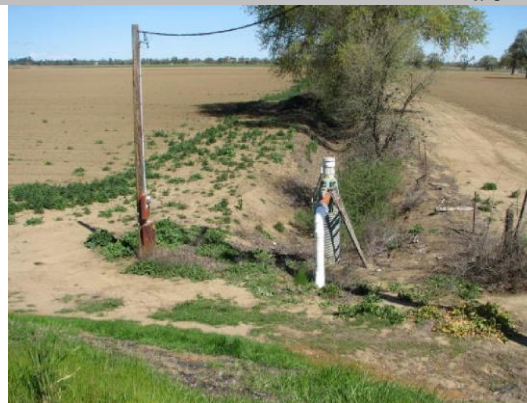
Photo 1 of 3 : UCIP\_SP\_2018\_33367\_60406.jpg

LM Start	5.56	Rating **	M	Issue No.	69
LM End	5.56	Issue Type +	En	Location *	
Category	Supplemental			GPS Latitude/Longitude	
				Start	End
Item	DWR UCIP Field Study			38.518250 °	38.518250 °
				-121.727685 °	-121.727685 °
DWR ID					
Comment Code					
Inspector Comment					
FS_ID:33367 DS_ID:590 EP_NO: 14140 Repair Type: Non-Urgent Crossing Status: Found UCIP Comments: Air vent broken off on water side shoulder. Also, no flap gate or other positive closure device on either side of levee. No requirement in permit for applicant to install positive closure device, but it may be necessary if maintenance or upgrade is performed on pipe. FIELD_STRUCT_DESC: 6-inch polyvinyl chloride (PVC) drainage pipe though the levee, 16 feet below the crown. 24-inch standpipe with pump on the landside (LS). Pipe outfall at creek with riprap. FS Date: 4/10/2014 2:35:30 PM

LS pump and pipe

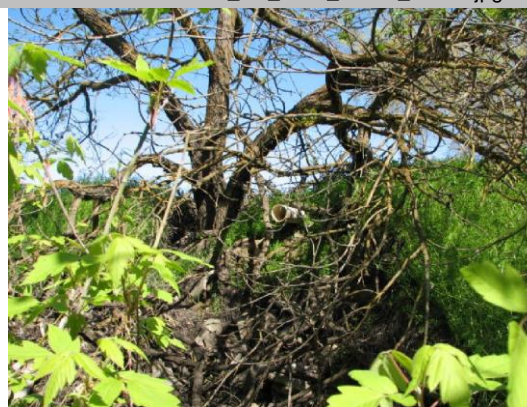
Photo 2 of 3 : UCIP\_SP\_2018\_33367\_60408.jpg

WS outfall at creek bank

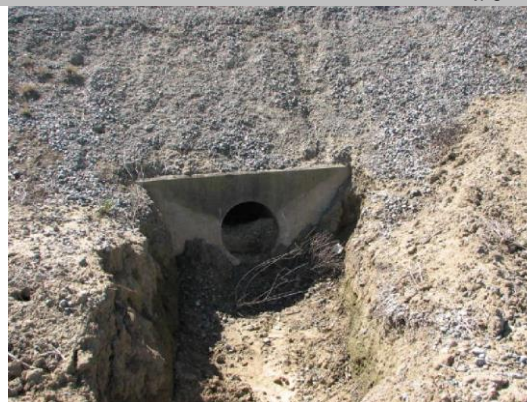
Photo 1 of 2 : UCIP\_SP\_2018\_33364\_60401.jpg

Comment Code					
Inspector Comment					
FS_ID:33364 DS_ID:503 EP_NO: 10252 Repair Type: No Action Needed Crossing Status: Found UCIP Comments: owner of pipe needs to clean out obstruction in pipe. FIELD_STRUCT_DESC: 24-inch corrugated metal drainage pipe through the levee, 12 feet below the crown. Slide gate on the waterside (WS) end. Concrete headwall on the landside (LS) end. (24-inch pipe [HLM 5.86] authorized under Automatic Board Order (ABO) issued as Permit No. 10252, 1974 - John F. Hamel). [Additional Reference(s): DWR Levee Log, 2005. USACE Sacramento O&M Manual 119, December 1952, (Station 108+00 PCT)]. FS Date: 4/10/2014 2:34:15 PM

LS headwall

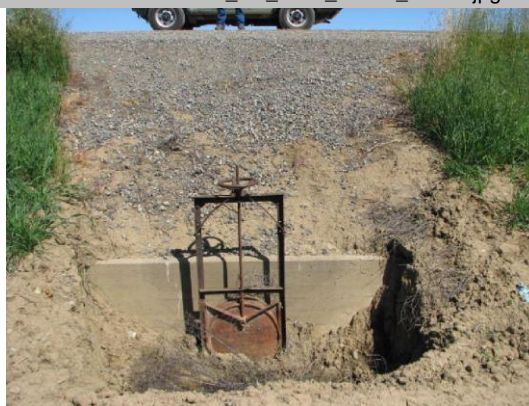
Photo 2 of 2 : UCIP\_SP\_2018\_33364\_60400.jpg

WS headwall and slidegate

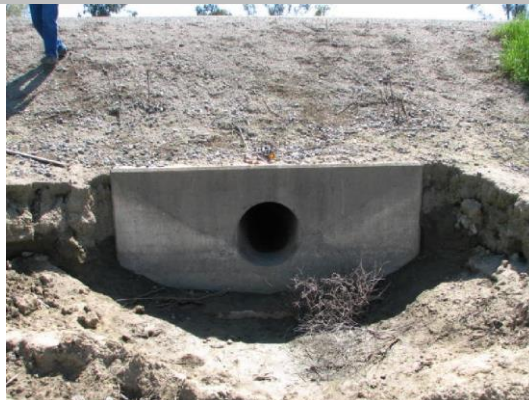
Photo 2 of 2 : UCIP\_SP\_2018\_33349\_60371.jpg

LS Headwall

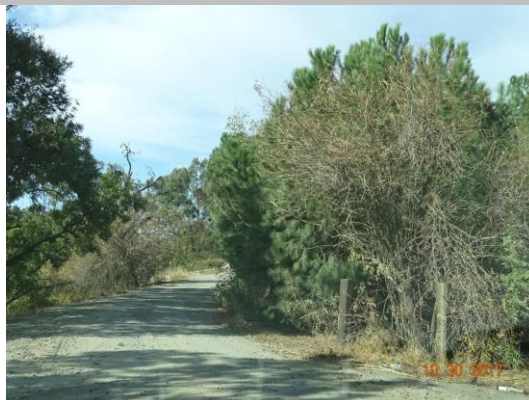
Photo 1 of 1 : SP\_2018\_ST0007\_282\_56\_20180305\_00009.jpg

LM Start	6.89	Rating **	M	Issue No.	56
LM End	6.89	Issue Type +	Ma	Location *	LS
Category	Earthen Levee			GPS Latitude/Longitude	
				Start	End
Item	Trim / Thin Trees			38.517513 °	38.517513 °
				-121.752023 °	-121.752023 °
DWR ID	DWR_ST0007_01_f_2017_56				
Comment Code					
T1 : Trim trees to at least five feet above ground level.					
Inspector Comment

Trees and bushes on landside block visibility and access. Includes elderberries.

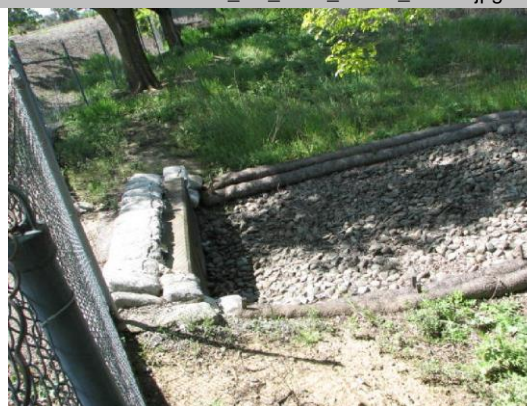
Photo 3 of 3 : UCIP\_SP\_2018\_33343\_60358.jpg

LS headwall

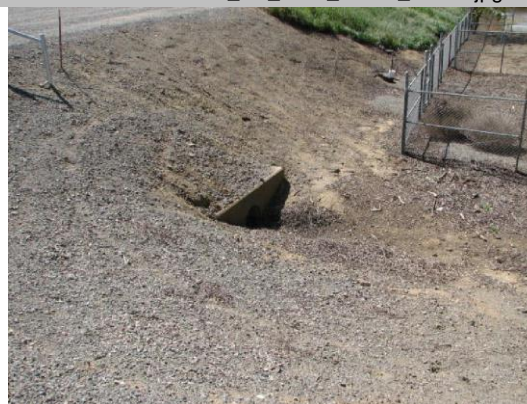
Photo 1 of 2 : UCIP\_SP\_2018\_42952\_60353.jpg

Comment Code					
Inspector Comment					
FS_ID:42952 DS_ID:512 EP_NO: 10247 Repair Type: No Action Needed Crossing Status: Found UCIP Comments: Debris removed from outlet FIELD_STRUCT_DESC: 24-inch drainage pipe of an unknown material through the levee, 12 feet below the crown. Flap gate on the waterside (WS) end. Concrete headwall on the landside (LS) end. (24-inch [HLM 7.36] authorized under Automatic Board Order (ABO) issued as Permit No. 10247, 1974 - University of California, Office of the Regents). [Additional Reference(s): DWR Levee Log, 2005. USACE Sacramento O&M Manual 119, December 1952, (Station 183+97 PCT)]. FS Date: 4/10/2014 2:27:00 PM

LS Headwall

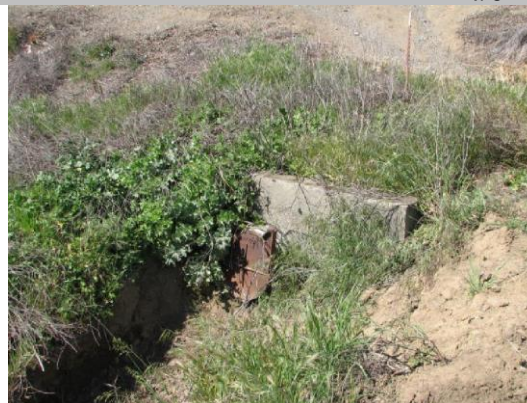
Photo 2 of 2 : UCIP\_SP\_2018\_42952\_60352.jpg

WS Flapgate

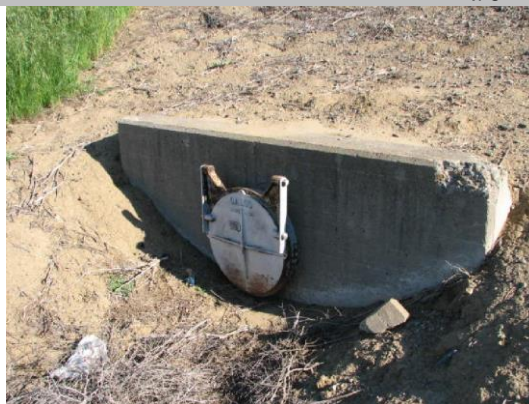
Photo 1 of 2 : UCIP\_SP\_2018\_41353\_60345.jpg

Comment Code					
Inspector Comment					
FS_ID:41353 DS_ID:516 EP_NO: 10260 Repair Type: Non-Urgent Crossing Status: Found UCIP Comments: Pipe is partially obstructed with sedimentation. Owner of pipe may have to clean sediment FIELD_STRUCT_DESC: 24-inch corrugated metal drainage pipe through the levee, 12 feet below the crown. Flap gate on the waterside (WS) end. (24-inch pipe [HLM 7.52] authorized under Automatic Board Order (ABO) issued as Permit No. 10260, 1974 - Southern Pacific Transportation Company). [Additional Reference(s): DWR Levee Log, 2005. USACE Sacramento O&M Manual 119, December 1952, (Station 193+20 PCT)]. FS Date: 4/10/2014 2:25:00 PM

WS Flap Gate and headwall.

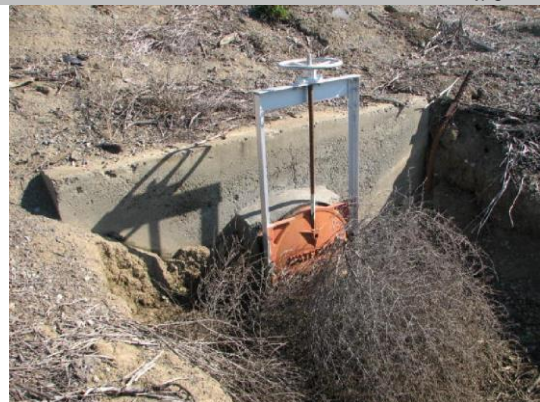
Photo 1 of 2 : UCIP\_SP\_2018\_33333\_60342.jpg

Comment Code					
Inspector Comment					
FS_ID:33333 DS_ID:518 EP_NO: 10247 Repair Type: No Action Needed Crossing Status: Found UCIP Comments: Fence blocking inlet. Owner of fence needs to move fence away from inlet. FIELD_STRUCT_DESC: 24-inch corrugated metal drainage pipe through the levee, 12 feet below the crown. Slide gate on the waterside (WS) slope, and headwalls on both sides. (24-inch pipe [HLM 7.75] authorized under Automatic Board Order (ABO) issued as Permit No. 10247, 1974 - University of California, Office of the Regents). [Additional Reference(s): DWR Levee Log, 2005. USACE Sacramento O&M Manual 119, December 1952, (Station 204+00 PCT)]. FS Date: 4/10/2014 2:24:52 PM

WS headwall and slide gate

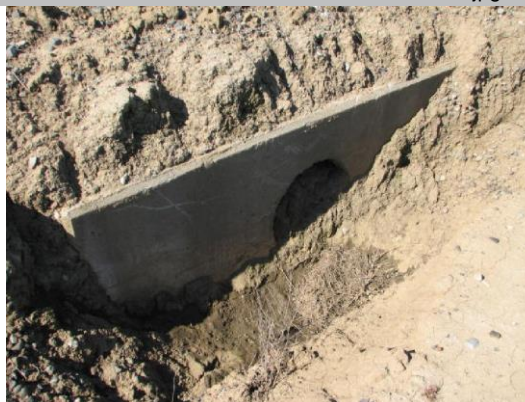
Photo 2 of 3 : UCIP\_SP\_2018\_33328\_60327.jpg

FS\_ID:33328  
DS\_ID:520  
EP\_NO: 10247  
Repair Type: No Action Needed  
Crossing Status: Found  
UCIP Comments: Cleaned inlet and outlets. Owner of pipe may need to clean pipe  
FIELD\_STRUCT\_DESC: 24-inch corrugated metal drainage pipe through the levee, 8 feet below the crown. Slide gate on the waterside (WS) end. (24-inch pipe [HLM 8.45] authorized under Automatic Board Order (ABO) issued as Permit No. 10247, 1974 - University of California, Office of the Regents). [Additional Reference(s): DWR Levee Log, 2005. USACE Sacramento O&M Manual 119, December 1952, (Station 241+50 PCT)].  
FS Date: 4/10/2014 2:23:46 PM

LS headwall showing pipe plugged with soil

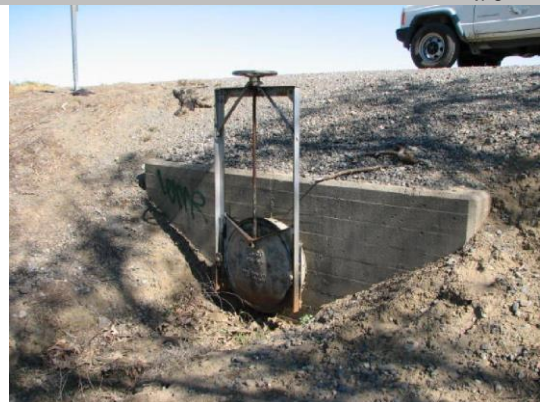
Photo 1 of 2 : UCIP\_SP\_2018\_33327\_60326.jpg

Comment Code						
Inspector Comment						
FS_ID:33327 DS_ID:521 EP_NO: 10247 Repair Type: No Action Needed Crossing Status: Found UCIP Comments: Removed material at slidegate and inlet. FIELD_STRUCT_DESC: 24-inch corrugated metal drainage pipe through the levee, 7 feet below the crown. Slide gate on the waterside (WS) end. Headwalls on both ends. (24-inch pipe [HLM 8.50] authorized under Automatic Board Order (ABO) issued as Permit No. 10247, 1974 - University of California, Office of the Regents. Also mentioned in Permit No. 5896, 1967 - The Regents of the University of California, Office of Architects and Engineers, University of California, Davis Campus). [Additional Reference(s): DWR Levee Log, 2005. USACE Sacramento O&M Manual 119, December 1952, (Station 244+20 PCT)]. FS Date: 4/10/2014 2:23:16 PM

WS headwall and slidegate

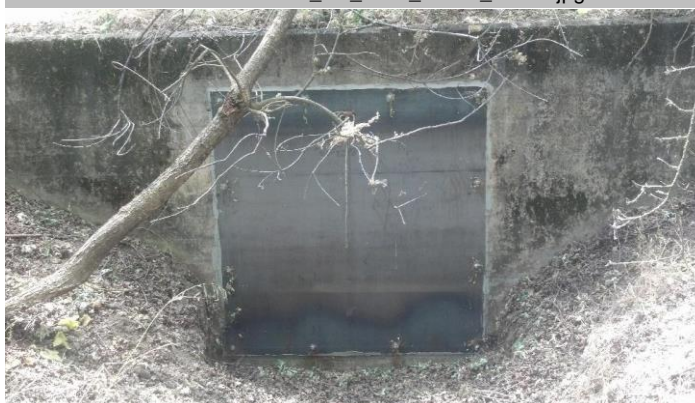
Photo 1 of 3 : UCIP\_SP\_2018\_41129\_60301.jpg

FS\_ID:41129  
DS\_ID:523  
EP\_NO: 10247  
Repair Type: Non-Urgent  
Crossing Status: Found  
UCIP Comments: \*ABANDONED\*  
FIELD\_STRUCT\_DESC: \*ABANDONED\* 48-inch drainage pipe of an unknown material through the levee, 15 feet below the crown. Steel plate installed over inlet off the landside (LS) toe. Pipe not grouted. Flap gate on waterside (WS) end. Headwalls on both ends. (48-inch pipe [HLM 8.88] authorized under Automatic Board Order (ABO) issued as Permit No. 10247, 1974 - University of California, Office of the Regents). [Additional Reference(s): DWR Levee Log, 2005. USACE Sacramento O&M Manual 119, December 1952, (Station 262+30 PCT)].  
FS Date: 4/10/2014 2:21:00 PM

Steel plate installed over pipe off LS toe.

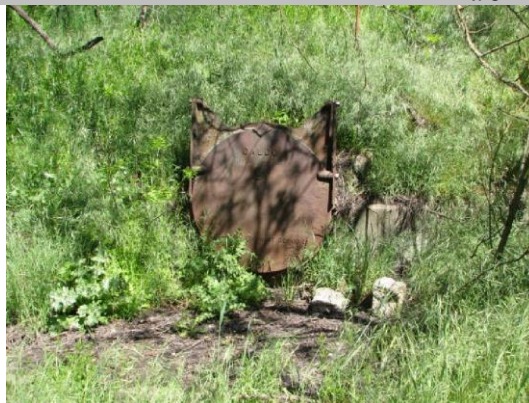
Photo 3 of 3 : UCIP\_SP\_2018\_41129\_60300.jpg

WS flap gate

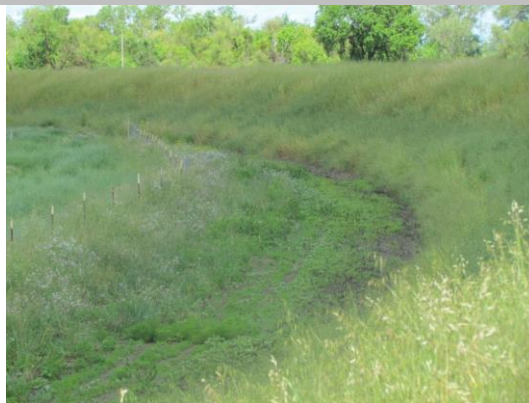
Photo 1 of 1 : SP\_2018\_ST0007\_283\_3\_20180305\_00001.jpg

LM Start	0.18	Rating **	U	Issue No.	3
LM End	0.31	Issue Type +	En	Location *	LS
Category	Earthen Levee			GPS Latitude/Longitude	
				Start	End
Item	Encroachments			38.507155 °	38.509035 °
				-121.682817 °	-121.663488 °
DWR ID	DWR_ST0007_02_s_2012_3				
Comment Code					
DT : Ditch					
Inspector Comment					
This ditch is within the 10-easement

Levee mile 0.18 looking upstream from the landside slope, irrigation ditch along the toe.

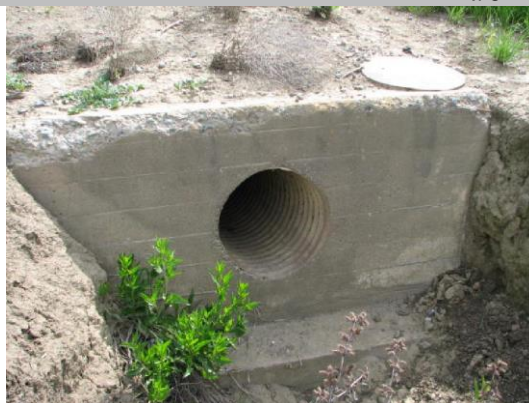
Photo 1 of 3 : UCIP\_SP\_2018\_33410\_60496.jpg

L/S headwall and pipe

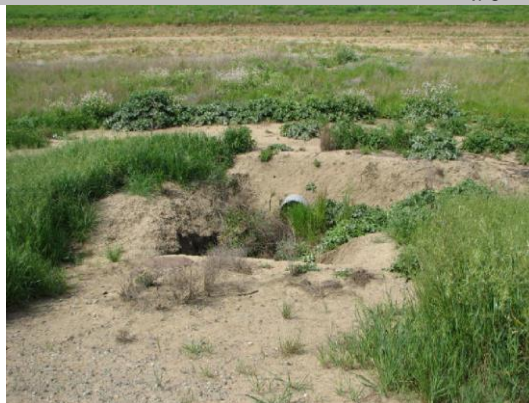
Photo 2 of 3 : UCIP\_SP\_2018\_33410\_60498.jpg

L/S headwall at pipe

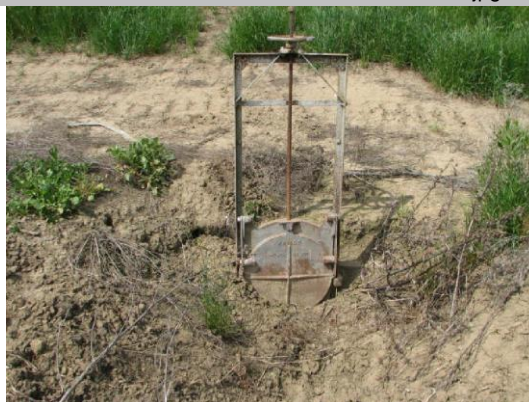
Photo 3 of 3 : UCIP\_SP\_2018\_33410\_60497.jpg

W/S slide gate

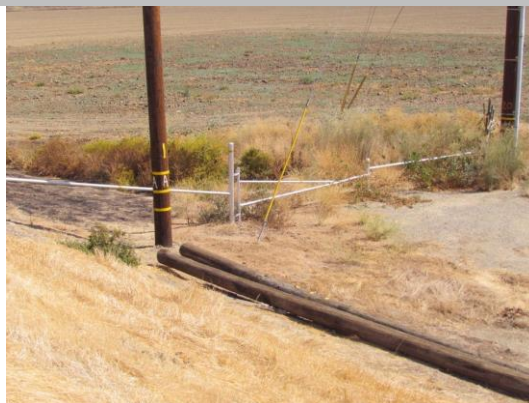
Photo 2 of 4 : SP\_2018\_ST0007\_283\_29\_20180305\_00007.jpg

Levee mile 0.55 landside slope and toe.

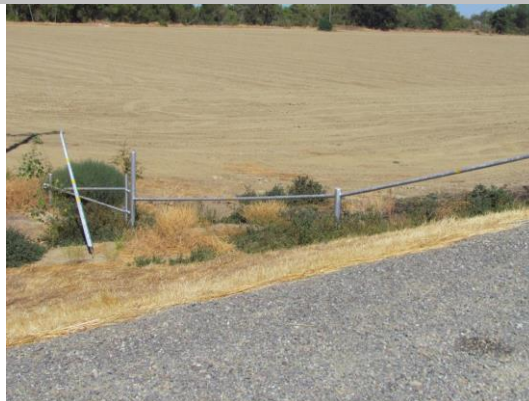
Photo 3 of 4 : SP\_2018\_ST0007\_283\_29\_20180305\_00008.jpg

Levee mile 0.55 waterside slope and toe.

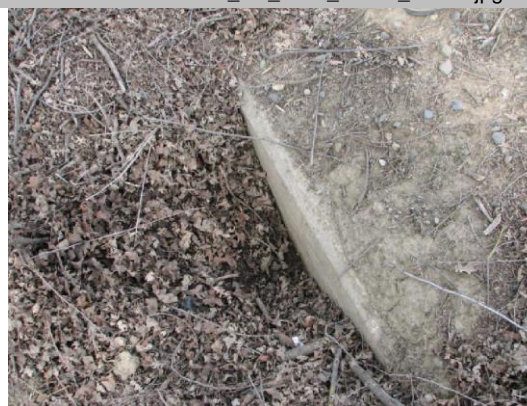
Photo 3 of 3 : UCIP\_SP\_2018\_41072\_60470.jpg

Comment Code						
Inspector Comment						
FS_ID:41072 DS_ID:16624 EP_NO: 10268 Repair Type: Non-Urgent Crossing Status: Found UCIP Comments: It is apparent that there is an irrigation pipe sleeved through the 25-inch pipe, but size cannot be determined. FIELD_STRUCT_DESC: 24-inch corrugated metal irrigation pipe through the levee, 13 feet below the crown. Gate valve on the landside (LS) in 10-inch concrete standpipe. 36-inch standpipe on the waterside (WS) toe. Headwall on the LS toe. (24-inch pipe authorized under Automatic Board Order (ABO) issued as Permit No. 10268, 1974 - Dow Chemical Company). [Additional Reference(s): DWR Levee Log, 2005. USACE Sacramento O&M Manual 119, December 1952, (Station P 265+70)]. FS Date: 4/10/2014 2:45:00 PM

LS headwall.

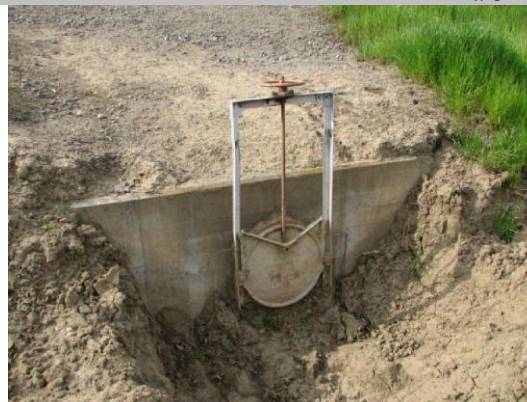
Photo 1 of 2 : UCIP\_SP\_2018\_33393\_60456.jpg

Item	DWR UCIP LMA Responsibility		38.515080 °	38.515080 °								
			-121.711050 °	-121.711050 °								
DWR ID												
Comment Code												
Inspector Comment												
FS_ID:33393 DS_ID:16626 EP_NO: 10277 Repair Type: No Action Needed Crossing Status: Found UCIP Comments: FIELD_STRUCT_DESC: 24-inch corrugated metal drainage pipe through the levee, 9 feet below the crown. Slide gate on the waterside (WS) slope, and headwalls on both sides. (24-inch pipe [HLM 3.11] authorized under Automatic Board Order (ABO) issued as Permit No. 10277, 1974 - Naomi Schoeningh). [Additional Reference(s): DWR Levee Log, 2005. USACE Sacramento O&M Manual 119, December 1952, (Station 50+72 PCT)]. FS Date: 4/10/2014 2:43:31 PM

WS headwall and slide gate

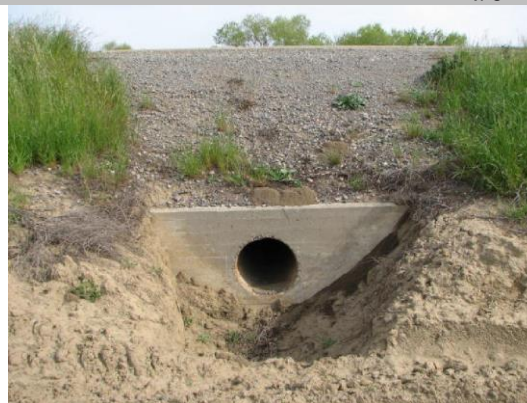
Photo 2 of 2 : UCIP\_SP\_2018\_33393\_60455.jpg

LS headwall and pipe

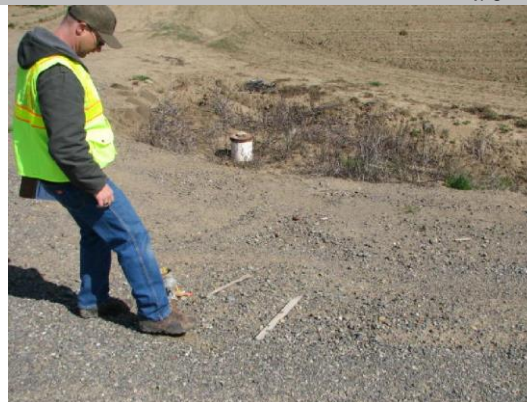
Photo 1 of 1 : UCIP\_SP\_2018\_33392\_60454.jpg

LM Start	3.18	Rating **	M	Issue No.	56
LM End	3.18	Issue Type +	En	Location *	
Category	Supplemental			GPS Latitude/Longitude	
				Start	End
Item	DWR UCIP Field Study			38.515161 °	38.515161 °
				-121.713634 °	-121.713634 °
DWR ID					
Comment Code					
Inspector Comment					
FS_ID:33392 DS_ID:16627 EP_NO: 2273A Repair Type: Non-Urgent Crossing Status: Indicator Found UCIP Comments: WS shoulder air vent looks broken and needs marker FIELD_STRUCT_DESC: 1 of 2: 18-inch coated steel irrigation pipe through the levee, 2 feet below the crown. Pump on well on the landside (LS). 18-inch standpipe on the waterside (WS) toe. Fresno valve on the LS toe, and air vent on the WS shoulder. 36-inch standpipe on the LS. (Permit No. 2273-A, 1980 - William B. Schoeningh). [Additional Reference(s): DWR Levee Log, 2005]. FS Date: 4/10/2014 2:43:17 PM

WS shoulder showing air vent with no sign and 18-inch standpipe at WS toe.

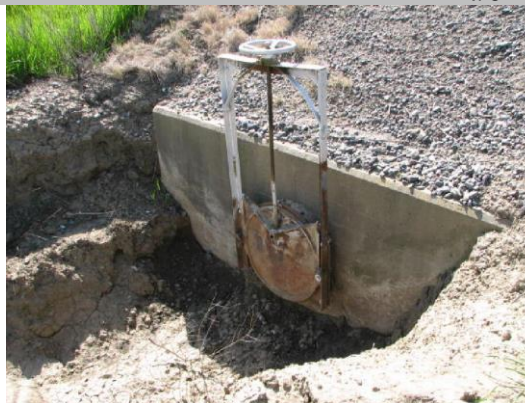
Photo 1 of 2 : UCIP\_SP\_2018\_33380\_60438.jpg

Comment Code					
Inspector Comment					
FS_ID:33380 DS_ID:16628 EP_NO: 10269 Repair Type: No Action Needed Crossing Status: Found UCIP Comments: 09/21/2017 Pipe was permitted as an irrigation structure under ABO issued as Permit No. 10269. (DWR UCIP - O. Magana) FIELD_STRUCT_DESC: 24-inch corrugated metal irrigation pipe through the levee, 12 feet below the crown. Slide gate on the waterside (WS) end. Concrete headwalls on both ends. (24-inch pipe [HLM 4.02] authorized under Automatic Board Order (ABO) issued as Permit No. 10269, 1974 - Joseph Fahn). [Additional Reference(s): DWR Levee Log, 2005. USACE Sacramento O&M Manual 119, December 1952, (Station 98+00 PCT)]. FS Date: 4/10/2014 2:40:00 PM

WS headwall and slide gate

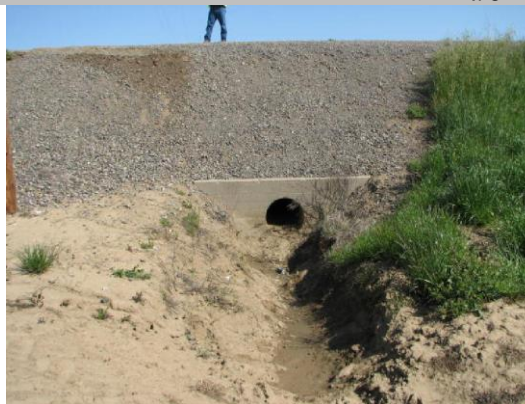
Photo 2 of 2 : UCIP\_SP\_2018\_33380\_60437.jpg

LS headwall

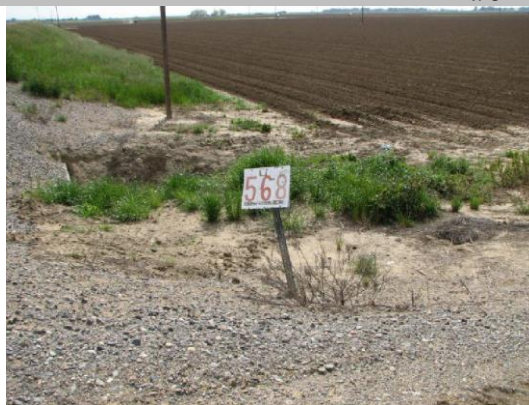
Photo 2 of 2 : UCIP\_SP\_2018\_33377\_60432.jpg

LS marker on east side of access ramp.

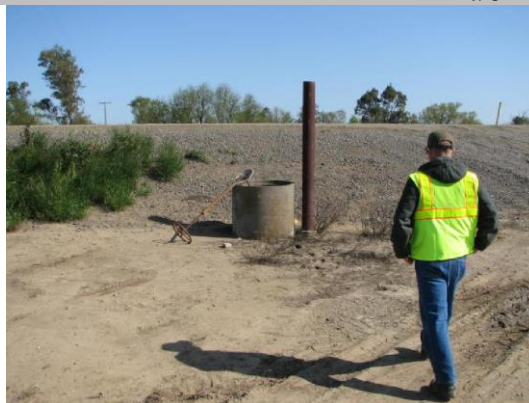
Photo 1 of 3 : UCIP\_SP\_2018\_33375\_60427.jpg

LM Start	4.66	Rating **	A/W	Issue No.	60
LM End	4.66	Issue Type +	Ma	Location *	
Category	Supplemental			GPS Latitude/Longitude	
				Start	End
Item	DWR UCIP LMA Responsibility			38.515814 °	38.515814 °
				-121.741030 °	-121.741030 °
DWR ID					
Comment Code					
Inspector Comment					
FS_ID:33375 DS_ID:16644 EP_NO: 10271 Repair Type: No Action Needed Crossing Status: Found UCIP Comments: FIELD_STRUCT_DESC: 24-inch corrugated metal drainage pipe through the levee, 9.5 feet below the crown. Flap gate on the waterside (WS). 36-inch standpipe on the landside (LS). (24-inch pipe [HLM 4.77] authorized under Automatic Board Order (ABO) issued as Permit No. 10271, 1974 - Ray H. Hamel). [Additional Reference(s): DWR Levee Log, 2005. USACE Sacramento O&M Manual 119, December 1952, (Station 136+40 PCT)]. FS Date: 4/10/2014 2:38:34 PM

LS 36-inch standpipe

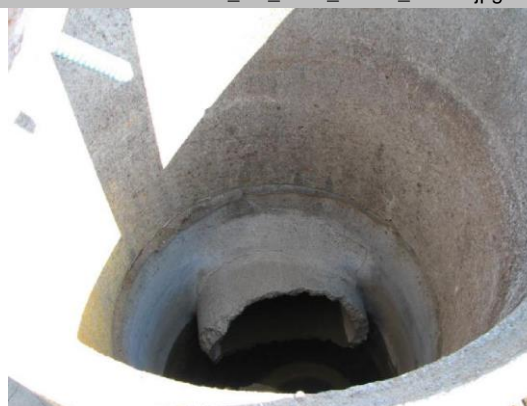
Photo 3 of 3 : UCIP\_SP\_2018\_33375\_60428.jpg

LS looking down standpipe at CC pipe

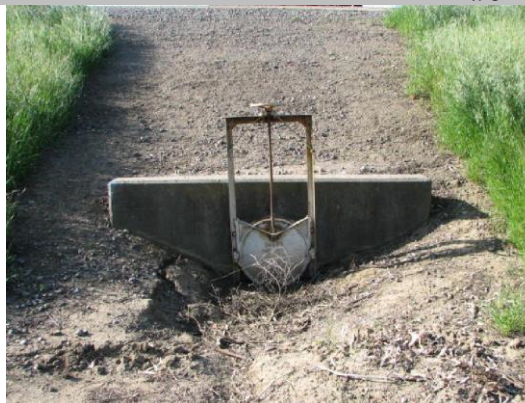
Photo 3 of 3 : UCIP\_SP\_2018\_33369\_60412.jpg

Comment Code						
Inspector Comment						
FS_ID:33369 DS_ID:16620 EP_NO: 10267 Repair Type: No Action Needed Crossing Status: Found UCIP Comments: Gate has been oiled and debris removed from outlet on land side FIELD_STRUCT_DESC: 24-inch corrugated metal drainage pipe through the levee, 13 feet below the crown. Slide gate on the waterside (WS) slope. Concrete headwalls on both ends. (24-inch pipe [HLM 5.56] authorized under Automatic Board Order (ABO) issued as Permit No. 10267, 1974 - Davis Laboratories, Inc.). [Additional Reference(s): DWR Levee Log, 2005. USACE Sacramento O&M Manual 119, December 1952, (Station 177+80 PCT)]. FS Date: 4/10/2014 2:35:57 PM

W/S positive closure device

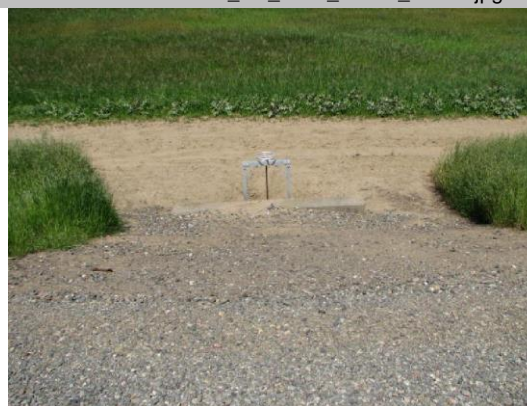
Photo 2 of 2 : UCIP\_SP\_2018\_33353\_60379.jpg

Comment Code						
Inspector Comment						
FS_ID:33353						
DS_ID:16641						
EP_NO: 10265						
Repair Type: No Action Needed						
Crossing Status: Found						
UCIP Comments: Pipe has some sedimentation buildup internally.						
FIELD_STRUCT_DESC: 24-inch corrugated metal drainage pipe						
through the levee, 11 feet below the crown. Slide gate on the waterside						
(WS) end. Concrete headwall on the landside (LS) end. (24-inch pipe						
[HLM 6.19] authorized under Automatic Board Order (ABO) issued as						
Permit No. 10265, 1974 - State of California, Division of Highways. Also						
included in Automatic Board Order (ABO) issued as Permit No. 11296,						
1974 - Capitol National Bank of Sacramento and Crocker Citizens						
National Bank). [Additional Reference(s): DWR Levee Log, 2005.						
USACE Sacramento O&M Manual 119, December 1952, (Station						
237+50 PCT)].						
FS Date: 4/10/2014 2:30:16 PM

WS slide gate

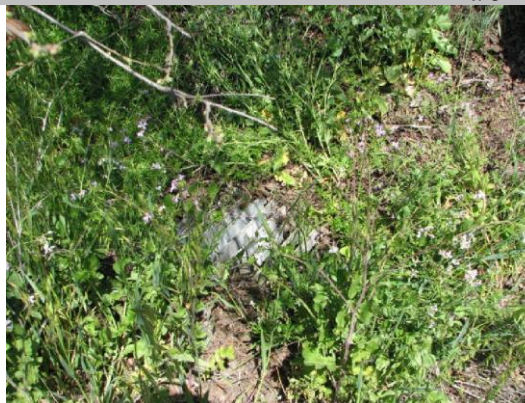
Photo 1 of 3 : UCIP\_SP\_2018\_33348\_60367.jpg

Comment Code					
Inspector Comment					
FS_ID:33348 DS_ID:16643 EP_NO: 7279 Repair Type: Non-Urgent Crossing Status: Found UCIP Comments: There is no handle on the slide gate operation mechanism and there is a large rootball blocking the outlet on WS. FIELD_STRUCT_DESC: 48-inch reinforced concrete drainage pipe through the levee, 26 feet below the crown. Slide gate in concrete box on the waterside (WS) slope of the levee. Drop inlet and weir inlet at the landside (LS) toe. Concrete headwall at outlet. Flap gate on the WS end is off. (Permit No. 7279, 1971 - State of California, Department of Public Works, Division of Highways and Bridges). [Additional Reference(s): DWR Levee Log, 2005]. FS Date: 4/10/2014 2:29:24 PM

Dropinlet at LS toe.

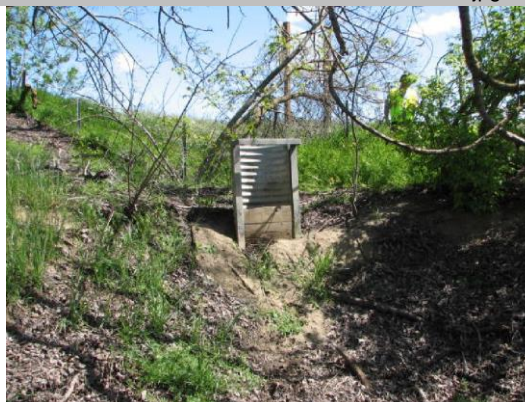
Photo 2 of 3 : UCIP\_SP\_2018\_33348\_60370.jpg

Weir inlet at pond on LS toe.

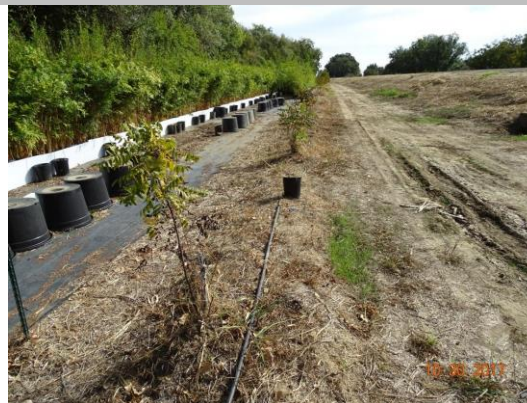
Photo 1 of 1 : SP\_2018\_ST0007\_283\_27\_20180305\_00004.jpg

LM Start	6.54	Rating **	M	Issue No.	27
LM End	6.70	Issue Type +	En	Location *	WS
Category	Earthen Levee			GPS Latitude/Longitude	
				Start	End
Item	Vegetation			38.518590 °	38.519875 °
				-121.774528 °	-121.776912 °
DWR ID	DWR_ST0007_02_f_2017_27				
Comment Code					
V6 : Landscaping					
Inspector Comment

Small nut trees planted on waterside berm should be removed.

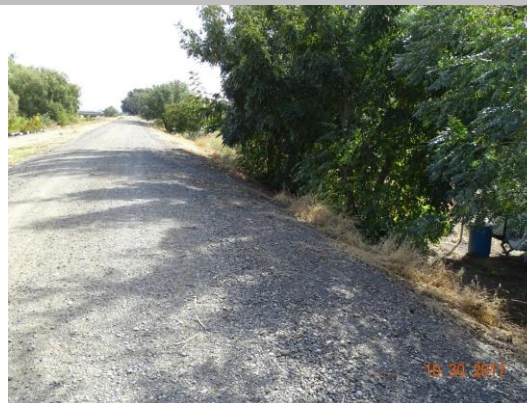
Photo 1 of 1 : SP\_2018\_ST0007\_283\_28\_20180305\_00005.jpg

LM Start	6.59	Rating **	M	Issue No.	28
LM End	6.66	Issue Type +	En	Location *	LS
Category	Earthen Levee			GPS Latitude/Longitude	
				Start	End
Item	Encroachments			38.519033 °	38.519538 °
				-121.775313 °	-121.776275 °
DWR ID	DWR_ST0007_02_f_2015_28				
Comment Code					
TR : Tree or limb					
Inspector Comment

Trees still partially obscure the landside slope and toe.

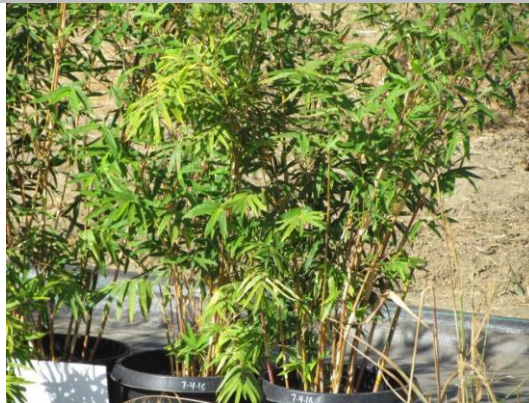
Photo 1 of 2 : SP\_2018\_ST0007\_283\_41\_20180305\_00011.jpg

LM Start	6.63	Rating **	U	Issue No.	41
LM End	6.71	Issue Type +	En	Location *	WS
Category	Earthen Levee			GPS Latitude/Longitude	
				Start	End
Item	Encroachments			38.519368 °	38.519953 °
				-121.775930 °	-121.777080 °
DWR ID	DWR_ST0007_02_s_2017_41				
Comment Code					
TR : Tree or limb					
Inspector Comment					
Bamboo being introduced by landowner on the waterside berm. This is unauthorized.

Putah Creek levee mile 6.63-6.74 unauthorized planting of arundo plants.
